GNSS overlay approaches

Pilot's Corner

By Anthony MacKay

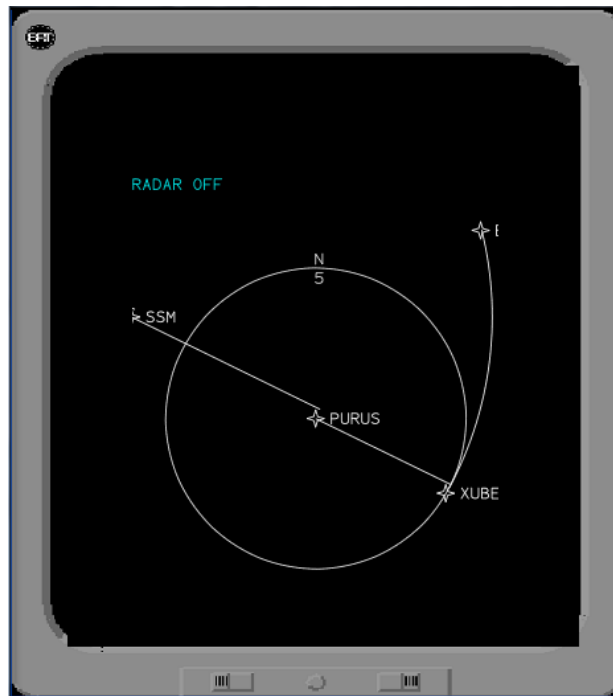
Here is an example of what was found on the VOR DME (GNSS) RWY 16 CYAM in the fall of 2013.

As you can see on the multi-function display (MFD), the flight path legs between XUBER, PURUS and SSM are all disconnected. The reaction of the aircraft was to overshoot the transition from the ARC to XUBER, then at PURUS the aircraft initiated a 15° bank turn to the right to regain the track from PURUS to SSM and the same thing happened from SSM to the runway.

Each FMS/GPS handles differences in magnetic variation differently between the onboard aircraft sources when using GPS as the navigator. When the approach is flown with reference to the VOR RADIAL as the primary navigation source, the aircraft is stable. However when it is flown with reference to the GPS as the primary navigator, the aircraft becomes unstable in roll while trying to make good the flight path between disconnected legs.
