GNSS overlay approaches

Pilot's Corner

By Anthony MacKay

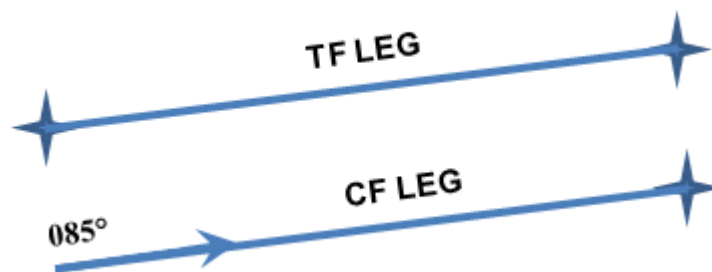
Figure 1: TF Leg vs CF Leg

TF legs are anchored at both ends by the latitude/longitude of the waypoints starting and ending the leg. CF legs are anchored on the ending fix only. This results in CF legs being very sensitive to magnetic variation discrepancies while TF legs are not affected by magnetic variation at all. TF legs will always tie together while CF legs can be disconnected. The magnitude of the disconnect is driven by the amount of magnetic variation difference between aircraft systems, navigation aids and the airport magnetic variation of record.
